The UK MOD Wreck Management Programme

Matt Skelhorn
Salvage and Marine Operations (SALMO)

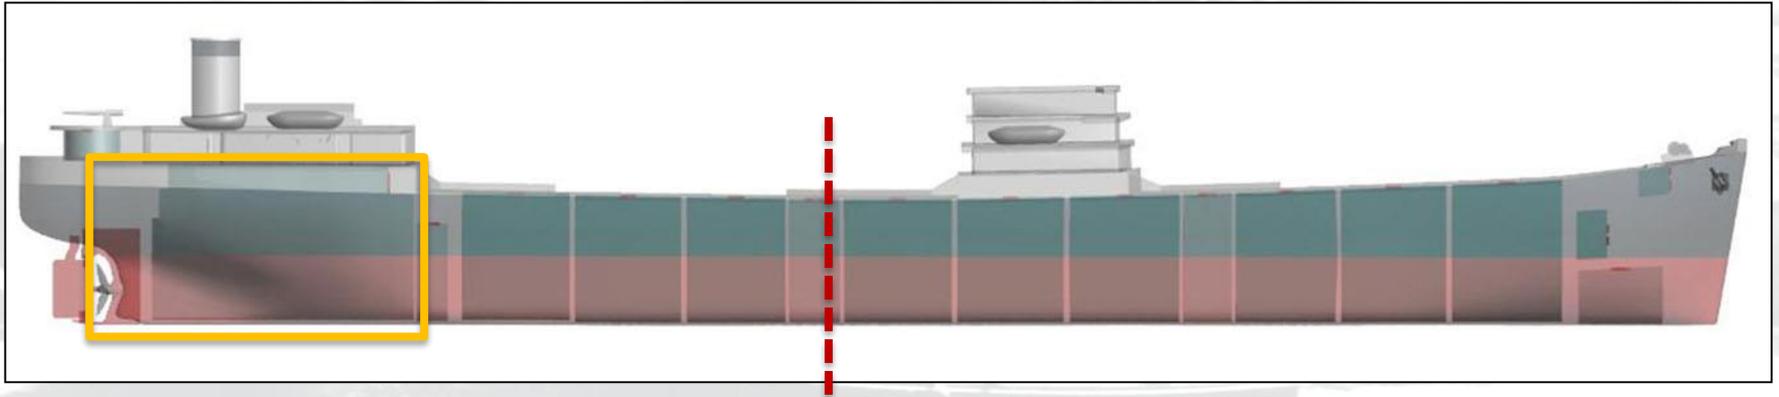
- Engine room likely to have torpedo damage to port side
- Mainly intact plating on starboard side will trap small residual quantities of oil

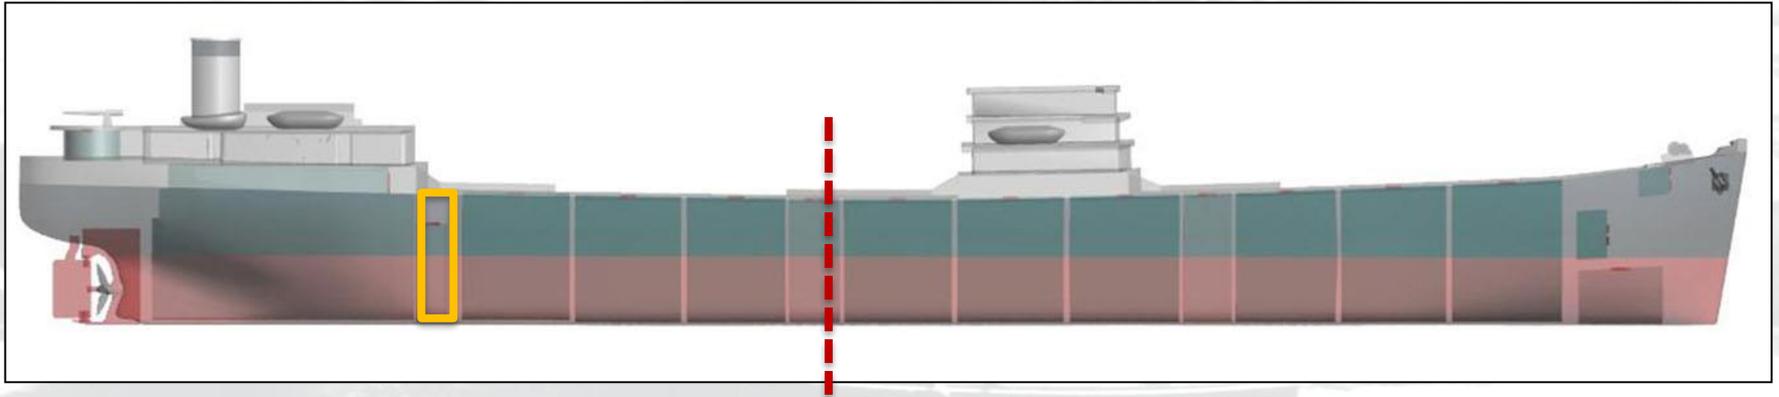
- Bunker tanks likely to contain some oil
- Most likely source of leak in 2010

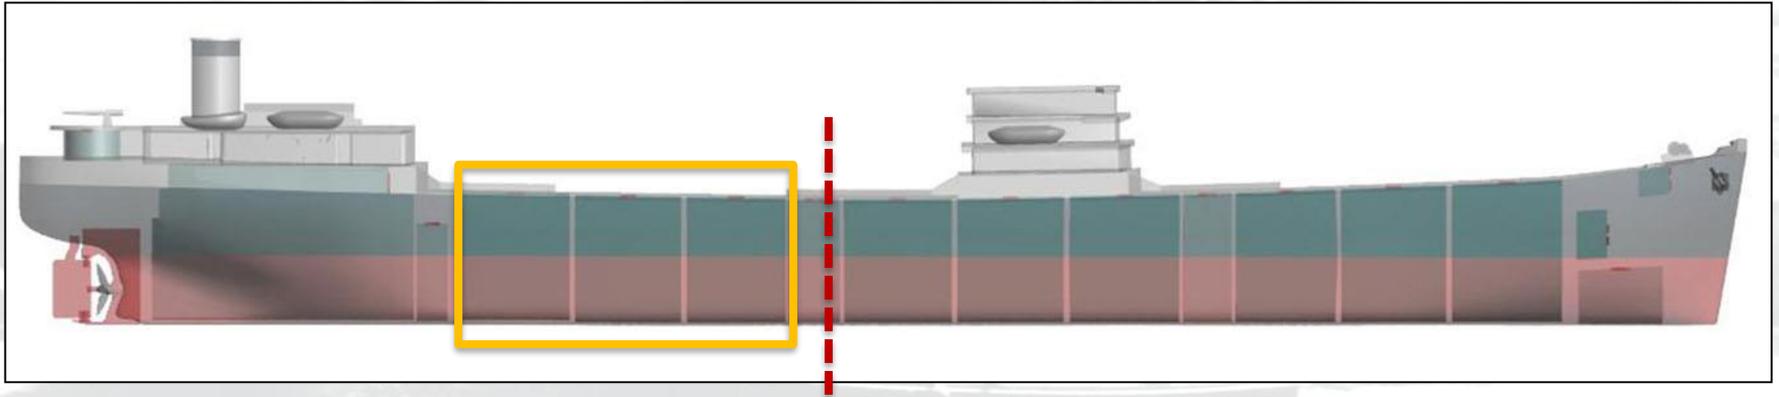
- Badly torpedo damaged
- Cargo tanks 1 to 3 open to the sea; no significant oil content

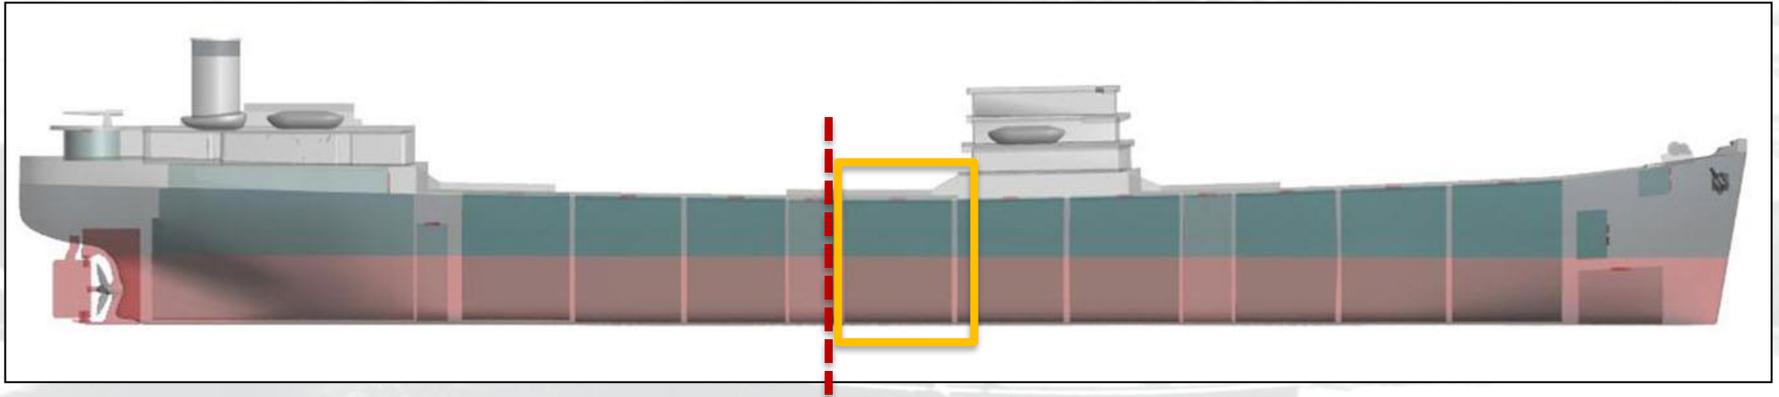
- No. 4 Cargo tank partially open to the sea but known to contain some oil
- Estimated to be circa 150m³

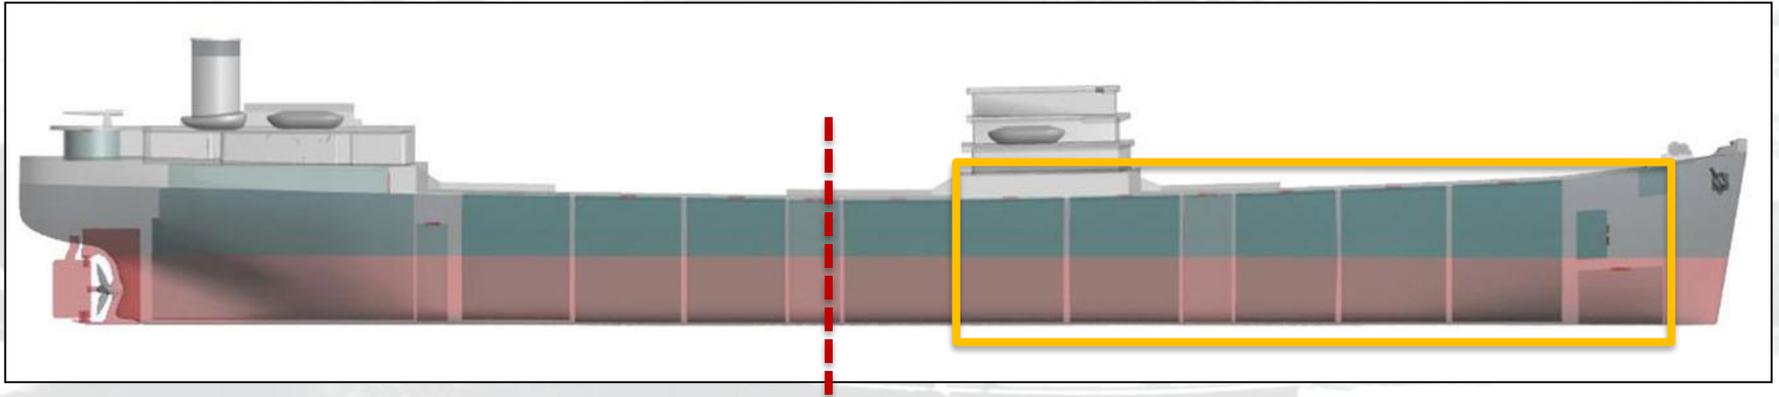
- Cargo tanks 5 to 9 intact
- Estimated quantity of oil remaining onboard 2800 to 4500m³
- Oil removal technically possible via hot tap but should be carried out in the near future to avoid thin steel causing difficulties

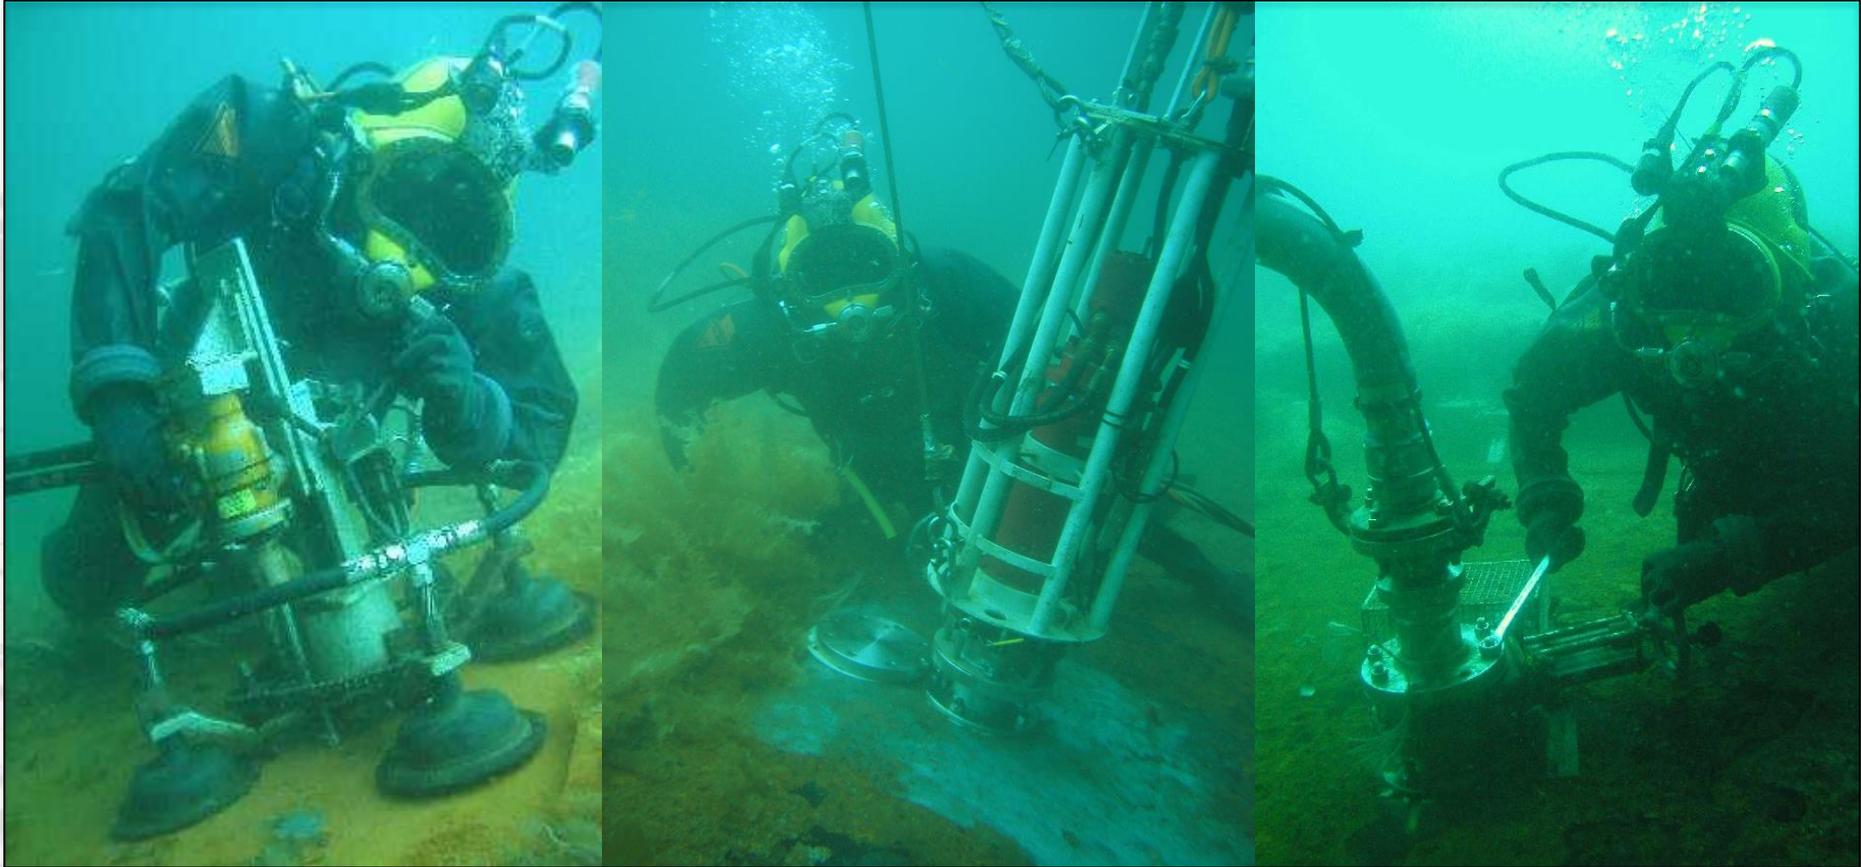
Hot Tapping – Gate Valves Fitted and Oil Removal

- 2001:**
170 cubic metres of oil recovered
- 2002:**
434 cubic metres of oil recovered
- 2003:**
July-August Hot tapping operations - 70 cubic metres of oil recovered
- 2004:**
Update of BMT Risk Assessment
July-August – Hot Tapping Operations - 26 cubic metres of oil recovered
- 2005:**
20 cubic metres of oil recovered from DB tanks
185 cubic metres of oil recovered using water jet cutting tool
- 2006:**
60 cubic metres of oil recovered from Port inner wing tanks using water jet cutter
- 2007:**
164 cubic metres of oil recovered from inner wing tanks and boiler room #3
- 2008:**
176 cubic metres of oil recovered from boiler rooms #1 and #2
- 2009:**
10 cubic metres of oil recovered from wing tank

1292 CUBIC METRES OF OIL RECOVERED TO 2009
