PRELIMINARY ACTION PLAN FOR THE RETRIEVAL ACTIVITIES ON THE FRANKEN SHIPWRECK

Report from the research expedition carried out on the Franken shipwreck on 23rd-28th April 2018 in the framework of the project
“Reduction of the negative impact of oil spills from the Franken shipwreck”

JUNE 2018

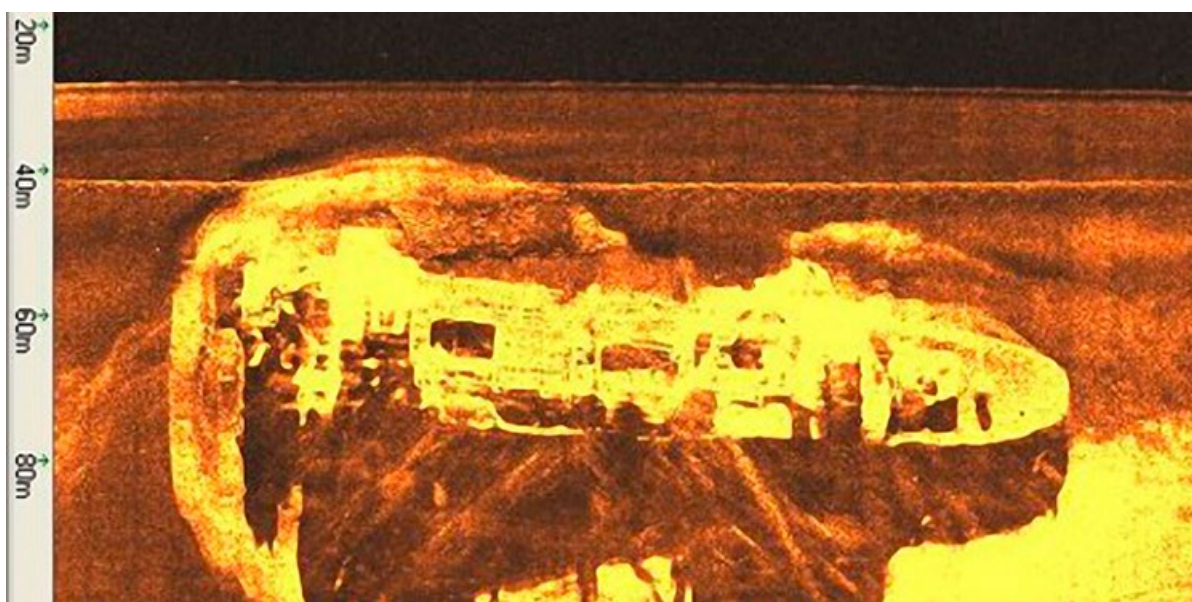
Figure 14. Sonar image of the sea bottom around the stern of the Franken shipwreck (data: Maritime Authority in Gdynia)

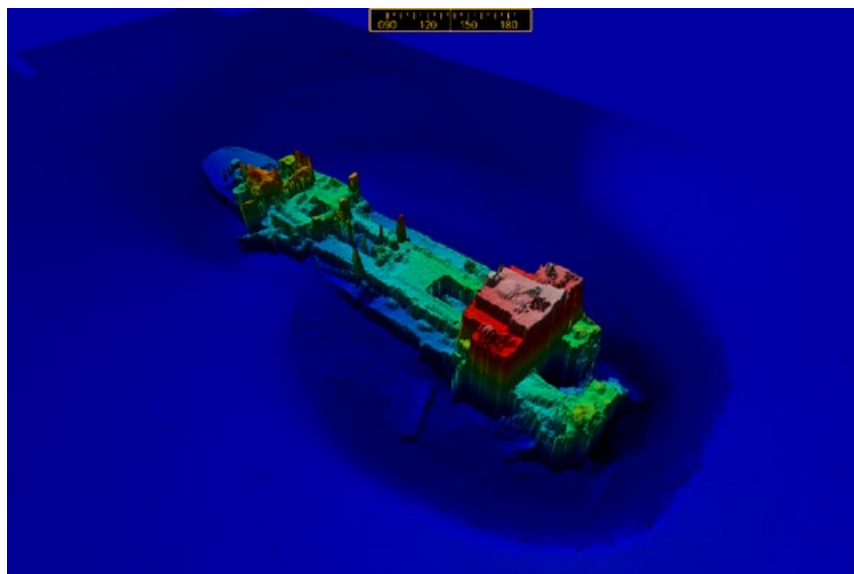
Figure 17. Bathymetric mapping of the bottom, longitudinal section along the starboard of the wreck, shows the washed out bottom in the forecastle section and a high shaft in the central section, closer to the stern, causing strong tension in this part (source: own information)

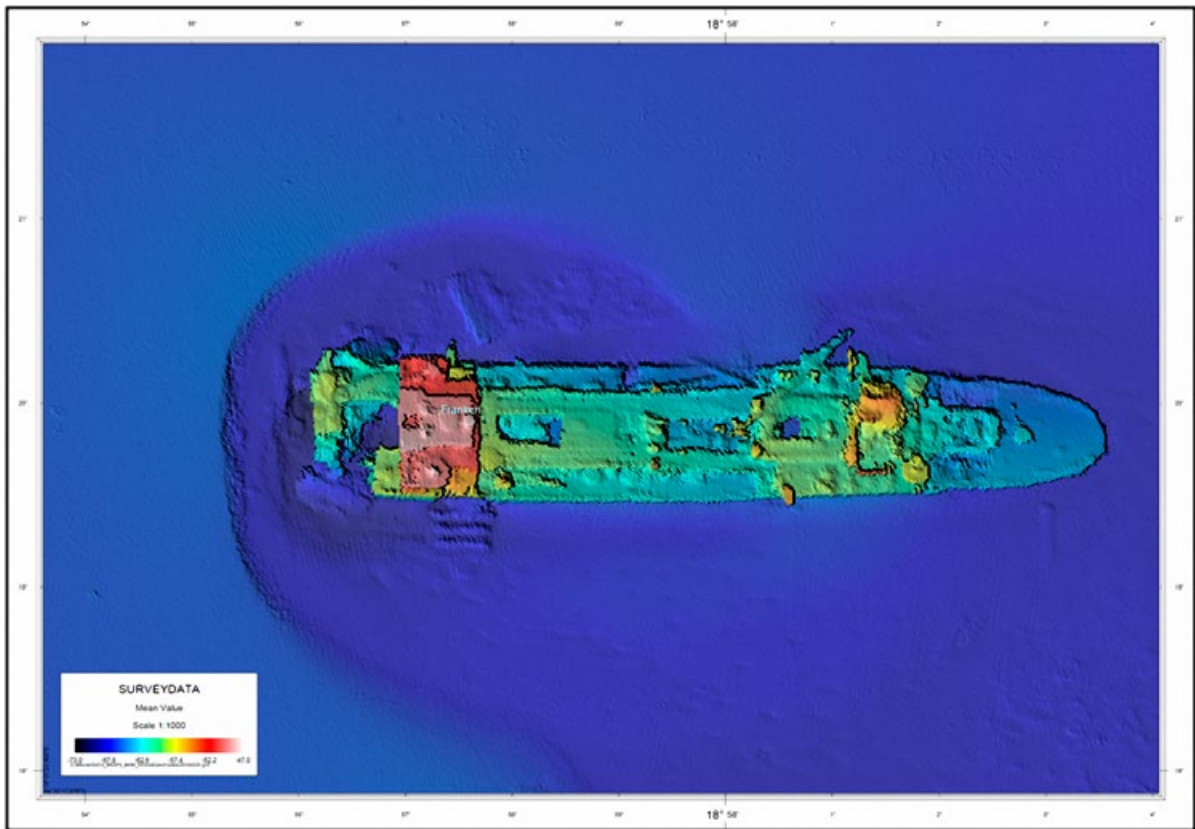
Figure 18. Bathymetric mapping of the bottom in the central section of the wreck

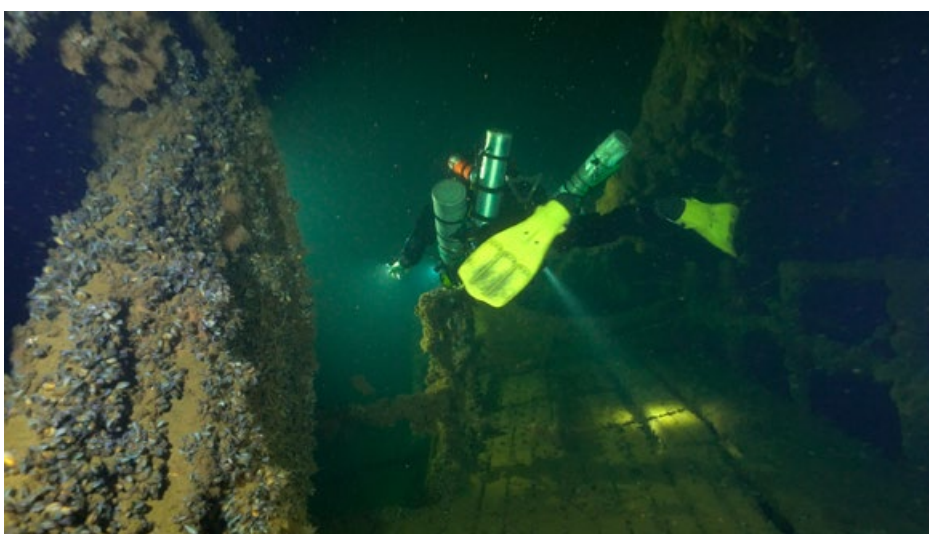
Photo 3. The deck on the larboard of the wreck in the midship
(source: 2018 expedition, © M. Pocaĵo)

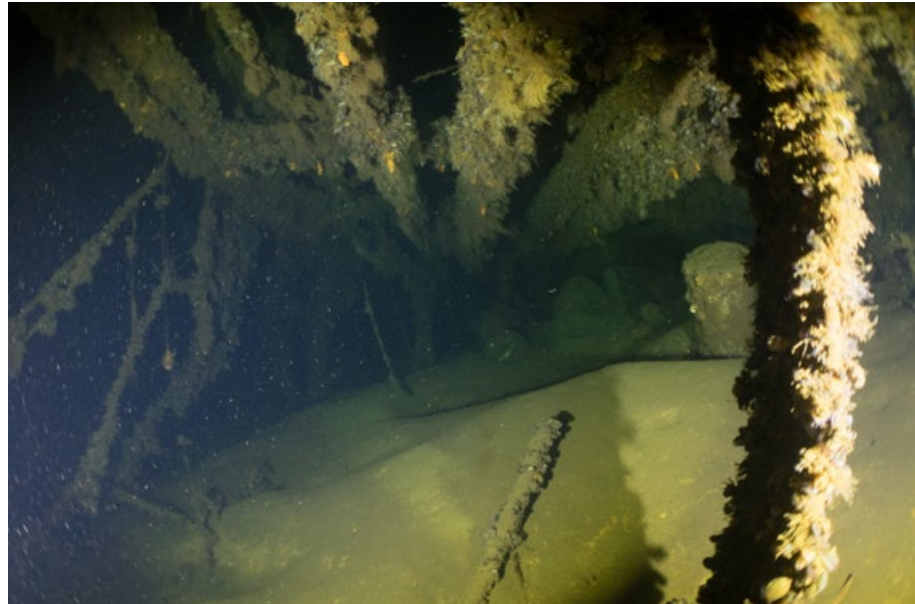
Photo 6. Derelict fishing nets hooked on the deck equipment (source: 2018 expedition, © M. Czermiński)

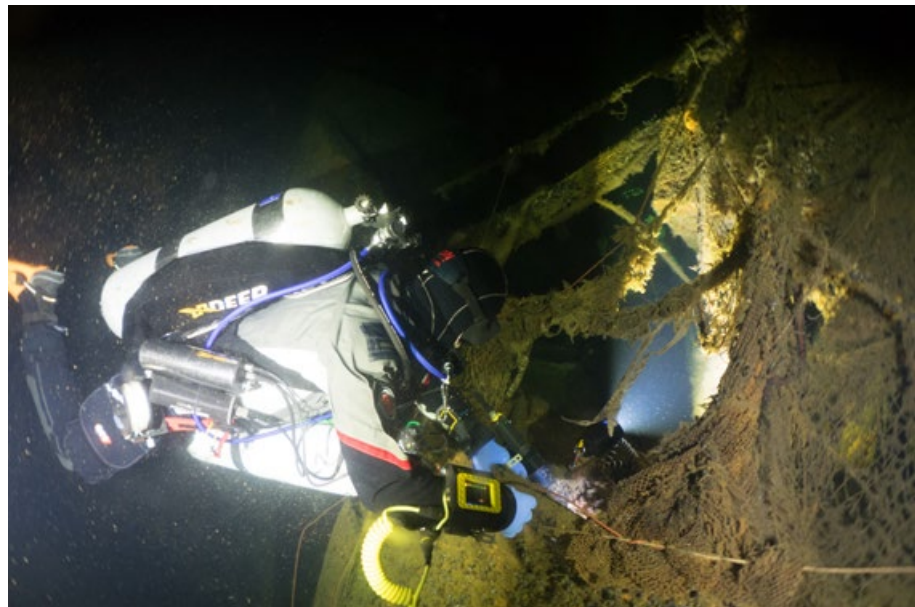
Photo 7. Fishing nets covering the deck equipment (source: 2018 expedition, © S. Pačko)

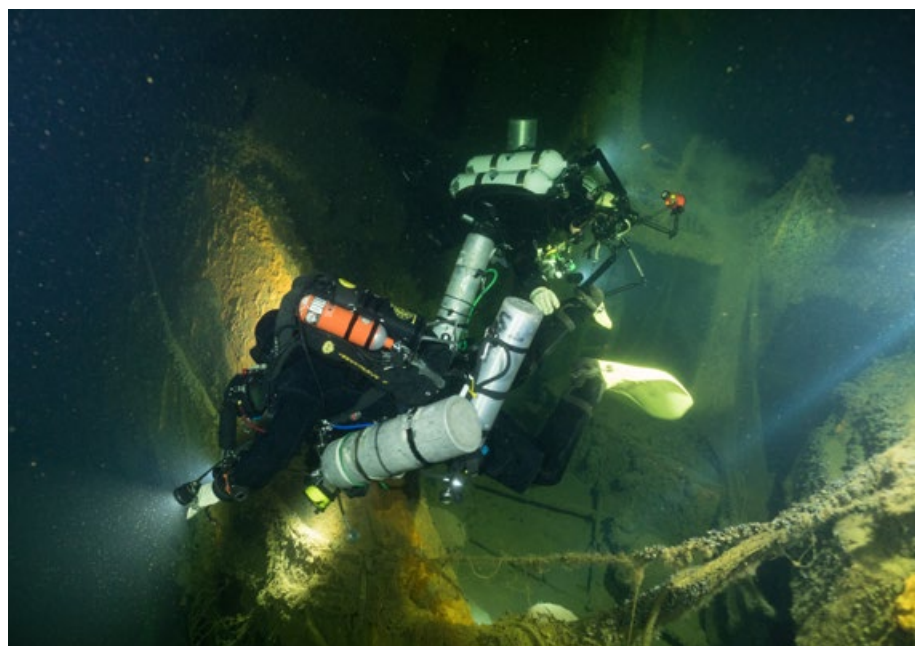
Photo 8. Equipment and litter on the main deck (source: 2018 expedition, © T. Trojanowicz)

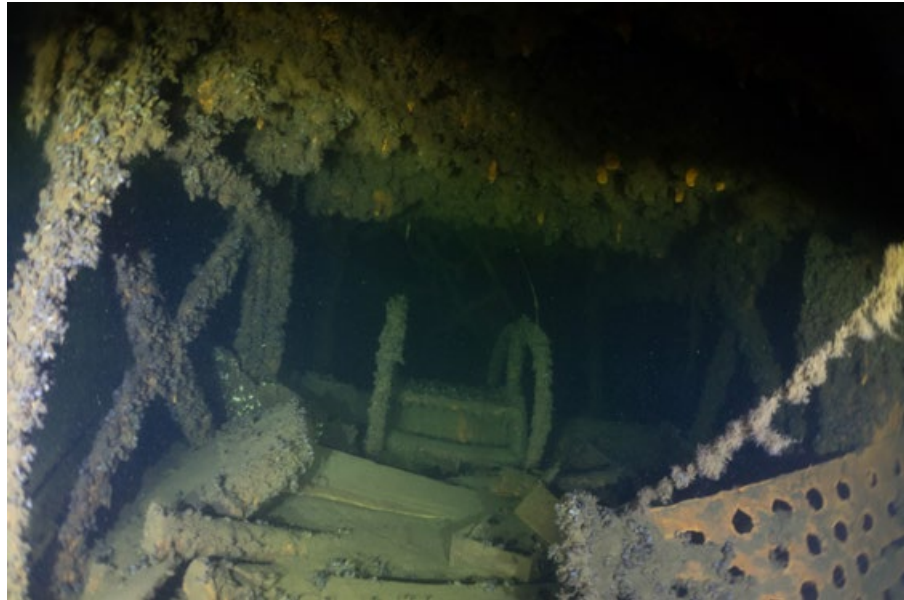
Photo 9. Broken equipment and litter blocking the entrance to the pumping rooms (source: 2018 expedition, © M. Czermański)

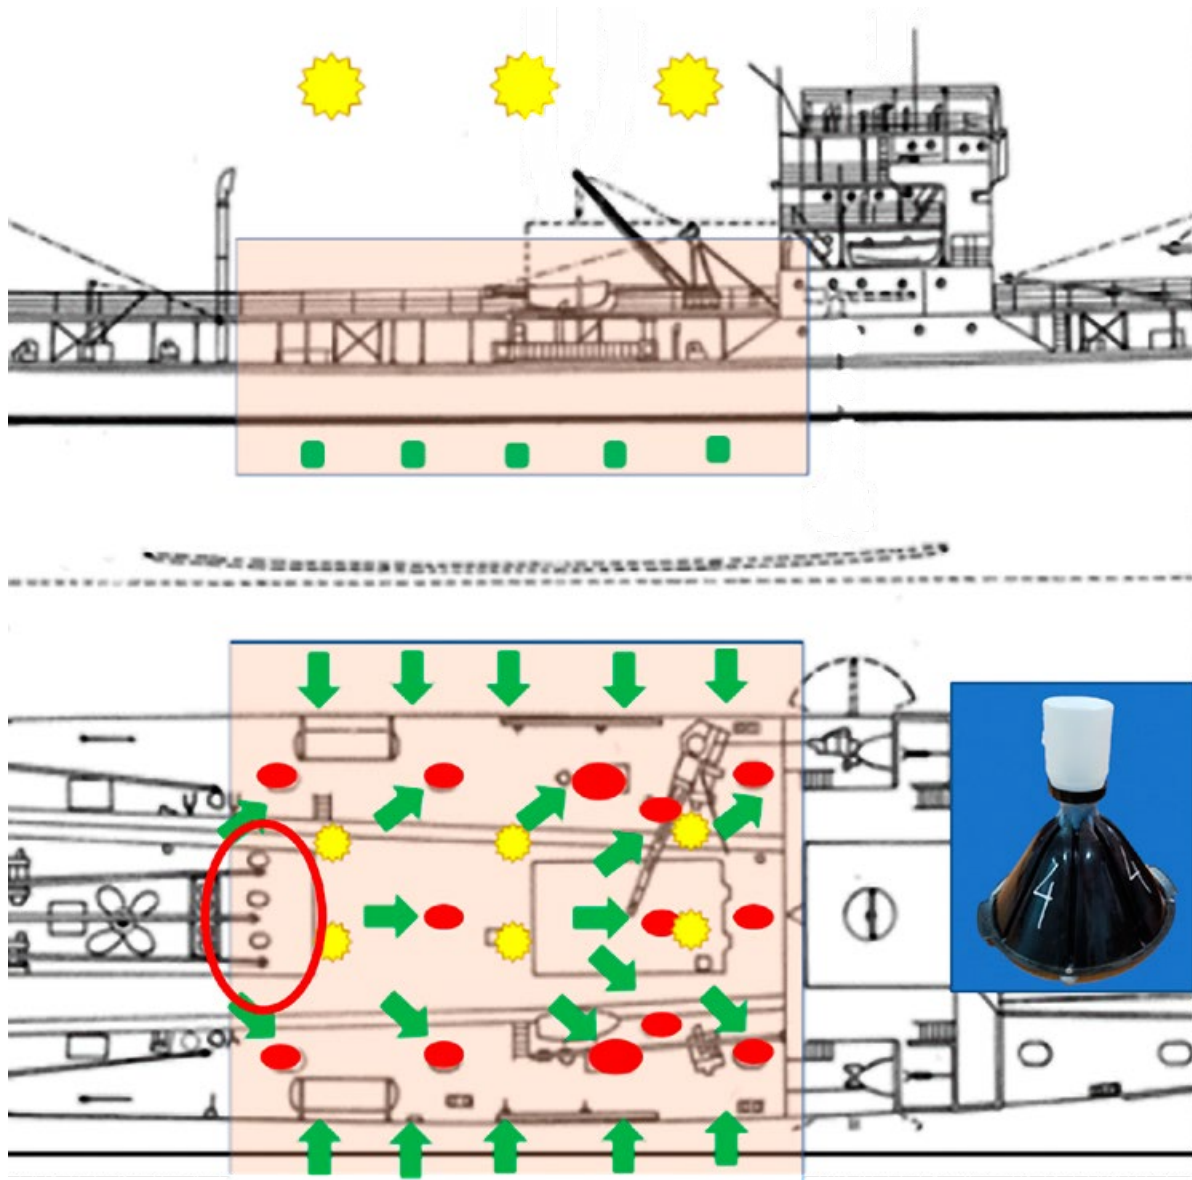
Figure 22. The section of the ship where tanks are located. Hatches to oil tanks are marked with red oval-shaped markings, green arrows indicate the spots which need to be controlled to see whether there are leakages. On the right, an oil sampling container (own source)

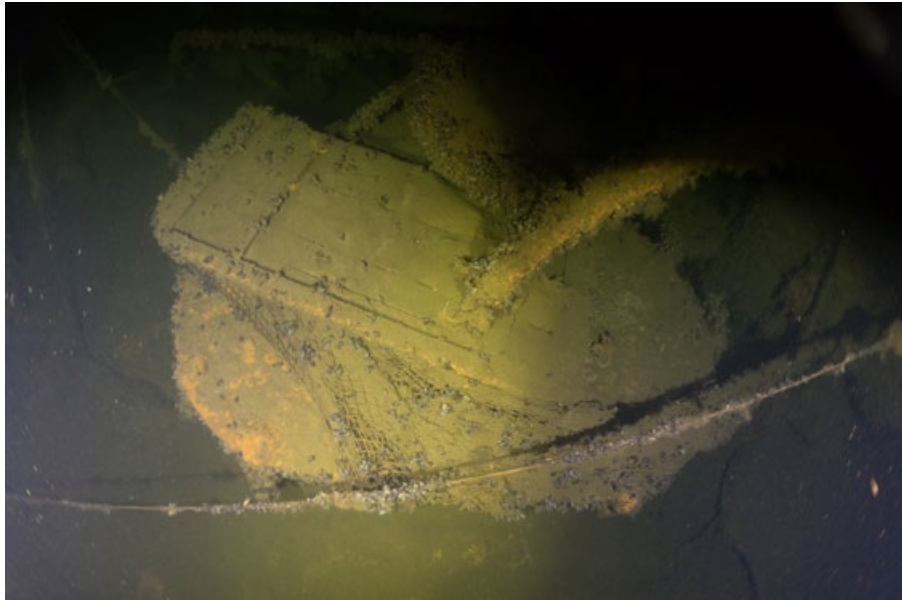
Photo 10. A hatch to an oil tank on the larboard (source: 2018 expedition, © M. Czermiński)

The divers carefully inspected the covers of the hatches (Photo10 to 16), where there is the highest probability of oil leakages. No leakages were spotted. This means that:

- The covers of the tanks are still tight,
- There is still no perforation on the main deck, exposed to direct impact of salt water,
- The tanks below the deck are filled with oil or some other substance, which protects the steel of the hull from corrosion, therefore the condition of the deck is unexpectedly good.

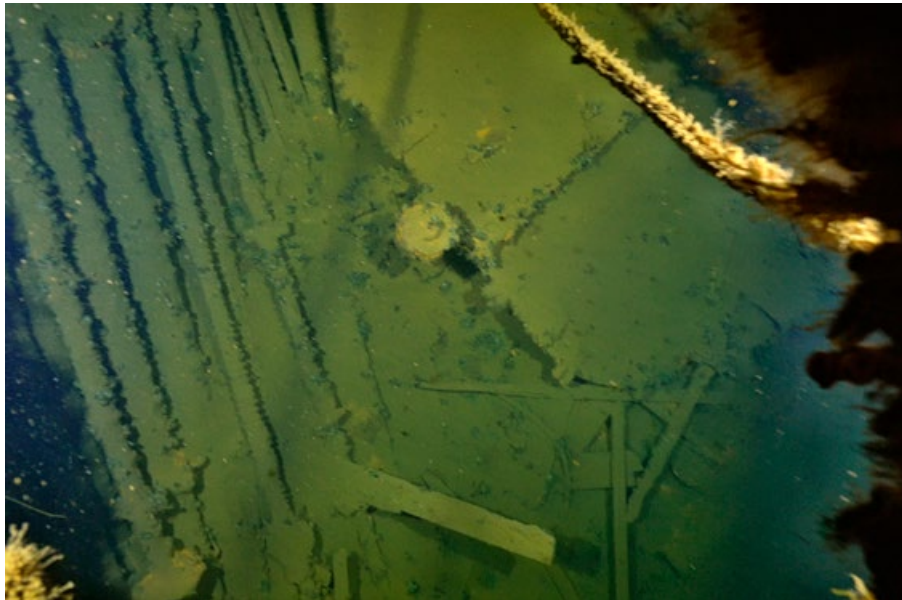
Photo 11. A hatch to an oil tank on the starboard (source: 2018 expedition, © S. Paćko)

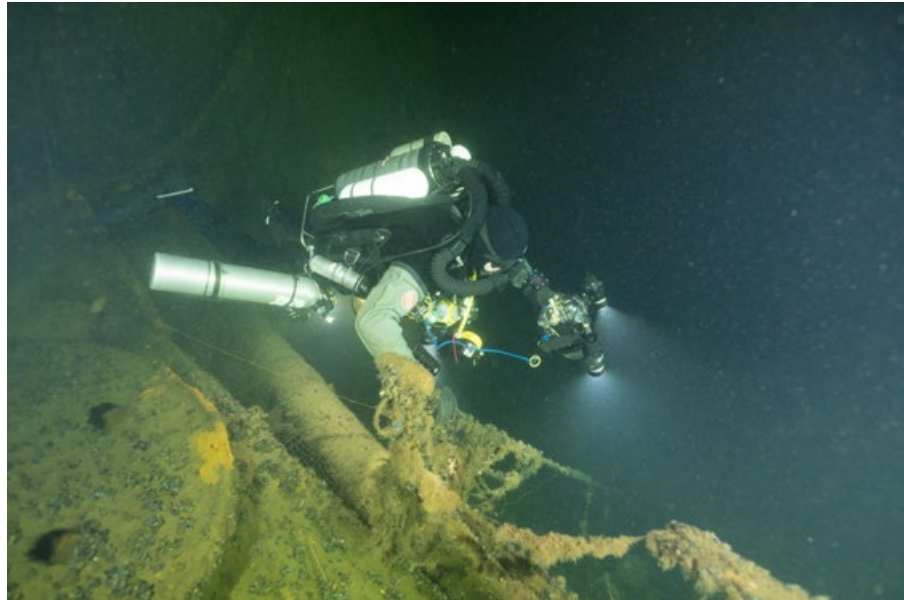
Photo 12. A hatch to an oil tank in the midship (source: 2018 expedition, © S. Paćko)

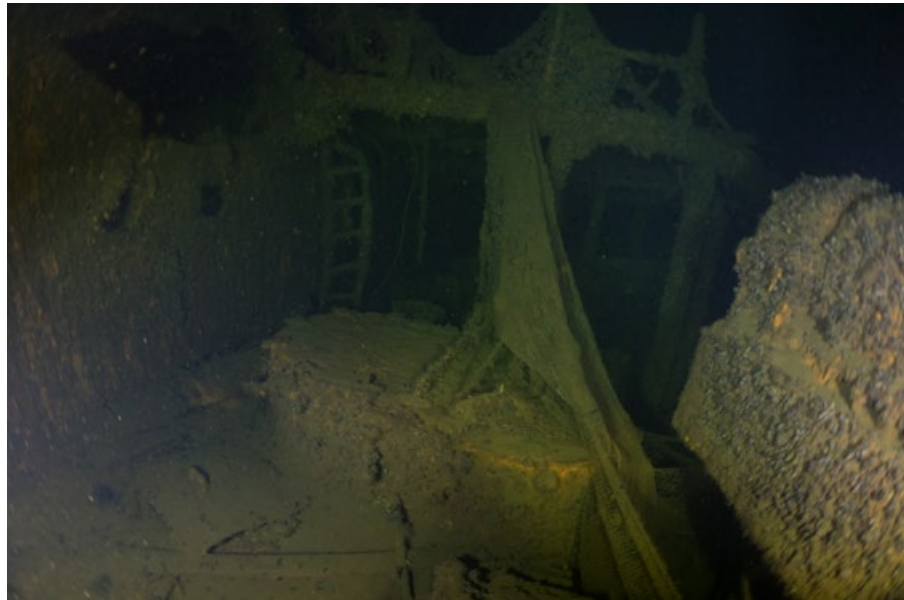
Photo 13. A hatch to an oil tank (source: 2018 expedition, © M. Czermiński)

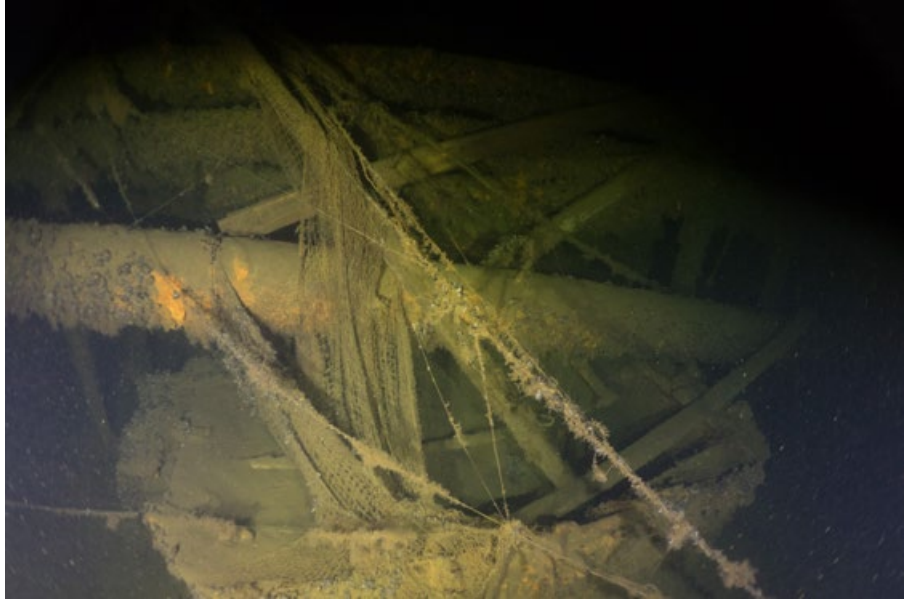
Photo 15. A hatch to an oil tank (source: 2018 expedition, © M. Czermiński)

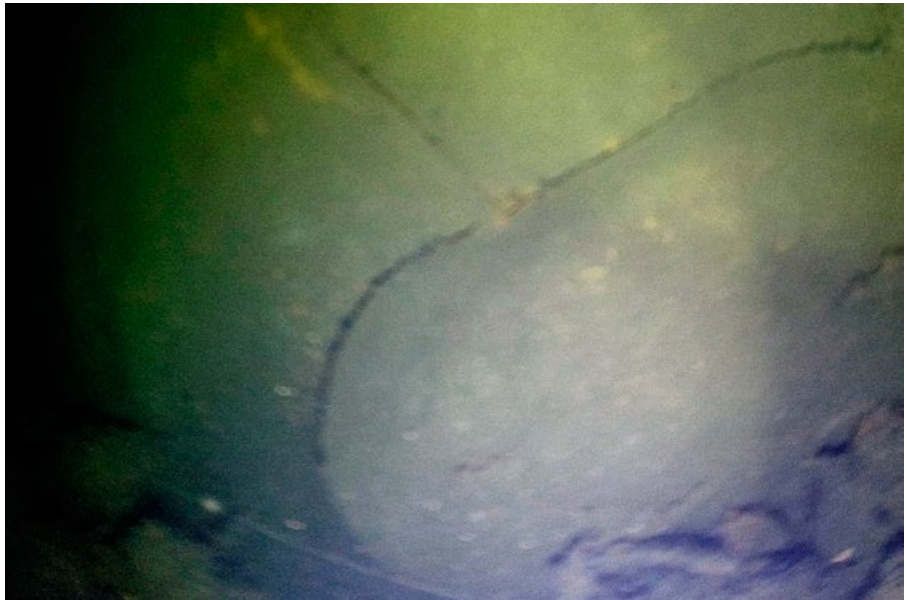
Photo 16. A hatch on the larboard in the direction of the stern (source: 2018 expedition, © M. Czermiński)

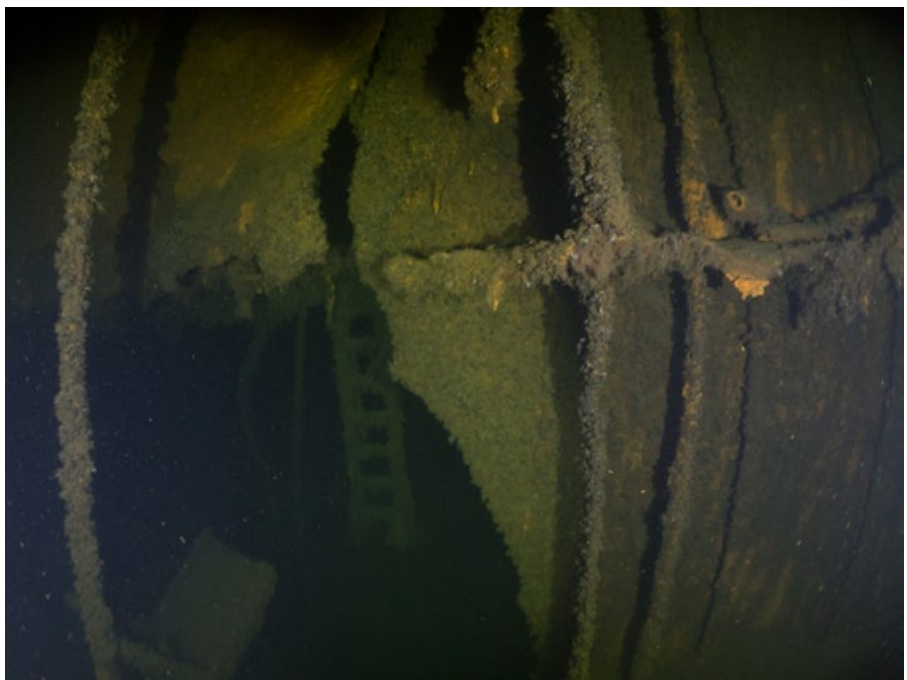
Photo 17. Broken bulkhead between the tanks under the forecandle (source: 2018 expedition, © M. Czermiński)

Some tanks were badly damaged during the bomb attack and after sinking (Photos 17 -19). A large part of the board is detached on the larboard, under the forecastle. The tank is probably empty, but there is a great chance that oil is trapped under the deck, in the frames and in some other well-hidden places. Despite the attempts, it was not possible to enter the tank. Therefore, it cannot be excluded that the tank is filled with heavy oil at the bottom, or light oil in its upper part. According to the divers, a similar situation takes place in the forecastle, where remaining oil can be observed in the recesses and niches.

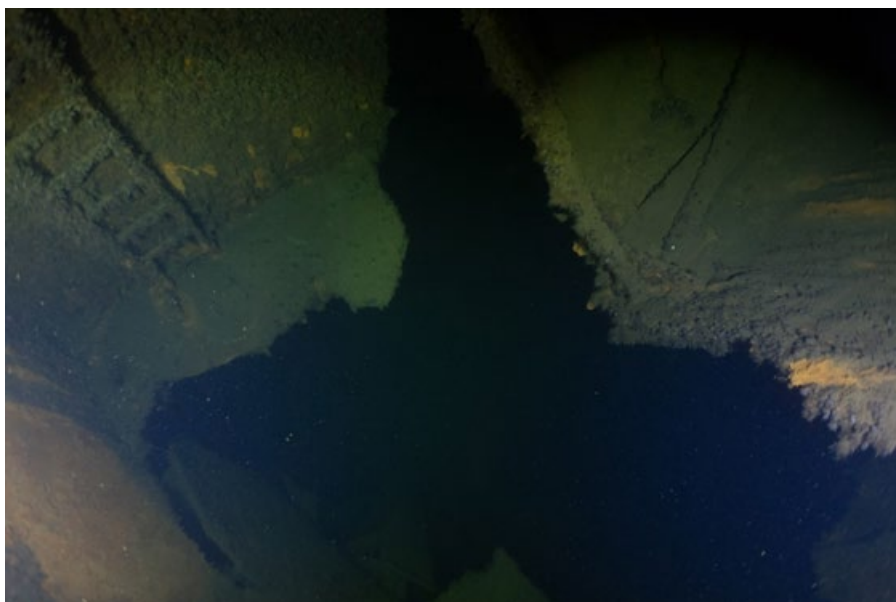
Photo 19. Broken hatch to the tank under the forecastle (source: 2018 expedition, © M. Czermiński)

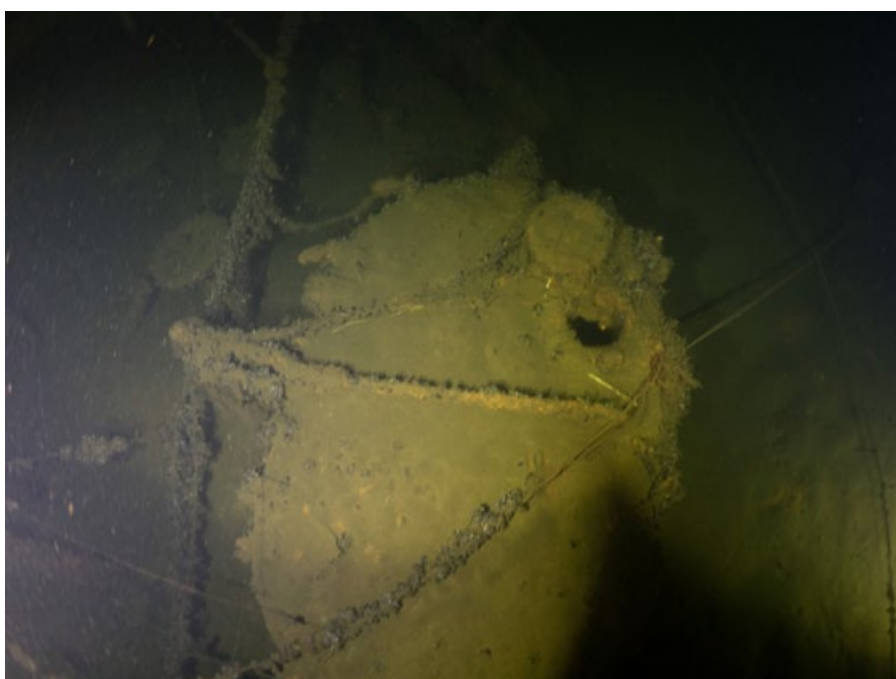
Photo 20. The tank hatch on the larboard, next to the forecastle. Visible inspection hatch. If the tank contained light oil, it is already empty, if it contained heavy oil, an inspection inside the tank is needed to confirm whether it is empty or full (source: 2018 expedition, © M. Czermiński)

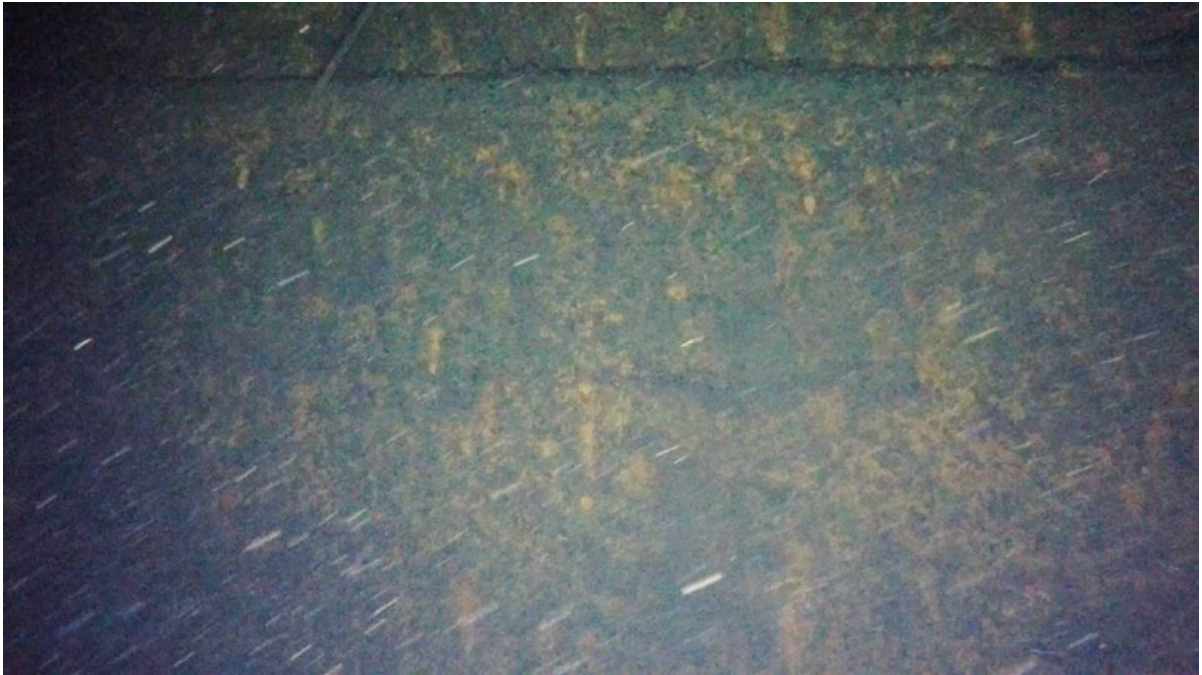
The stern and sterncastle as well as the forecandle were also documented. Pictures taken with GoPro were executed in parallel to the measurements performed with the acoustic camera. Due to the poor lighting conditions, the quality of many pictures is poor, the photographs are very dark and do not show too many details. However, a mosaic of the larboard and starboard was made on the basis of the photographs taken by the RPV with GoPro. These parts around the holds do not show significant damage (Photo 23 and Photo 24).

Photo 23. The starboard next to an oil tank (source: 2018 expedition)

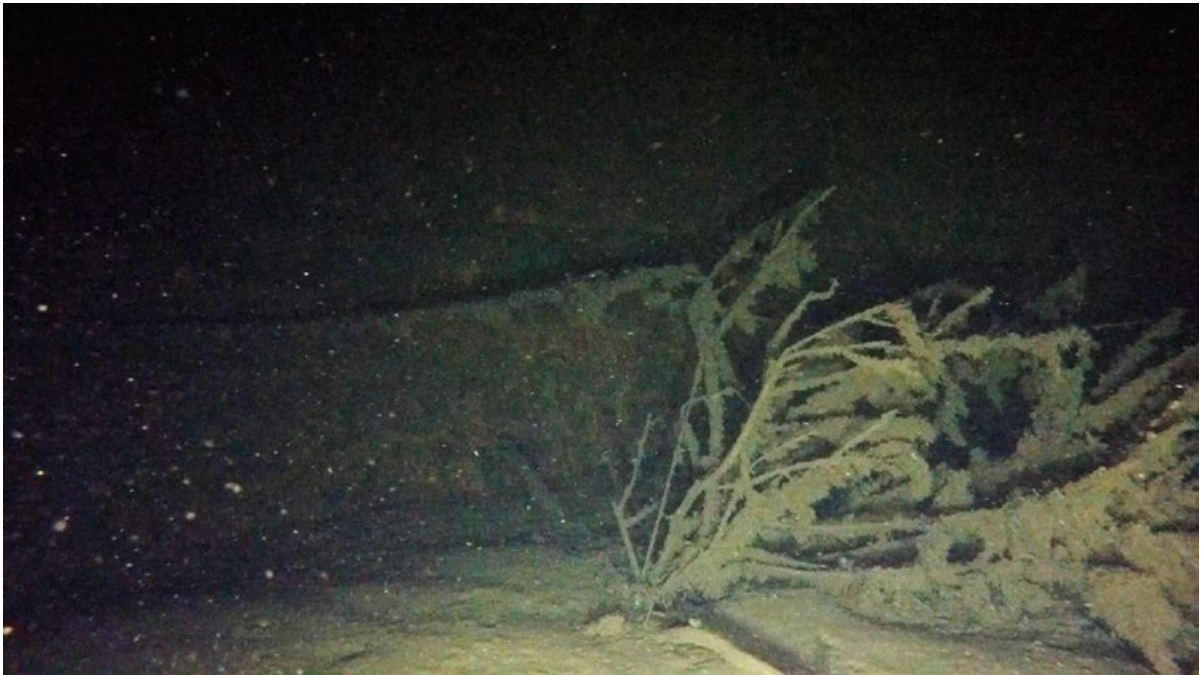
Photo 24. The larboard next to the oil tanks, visible branch brought by the Vistula river (source: 2018 expedition)

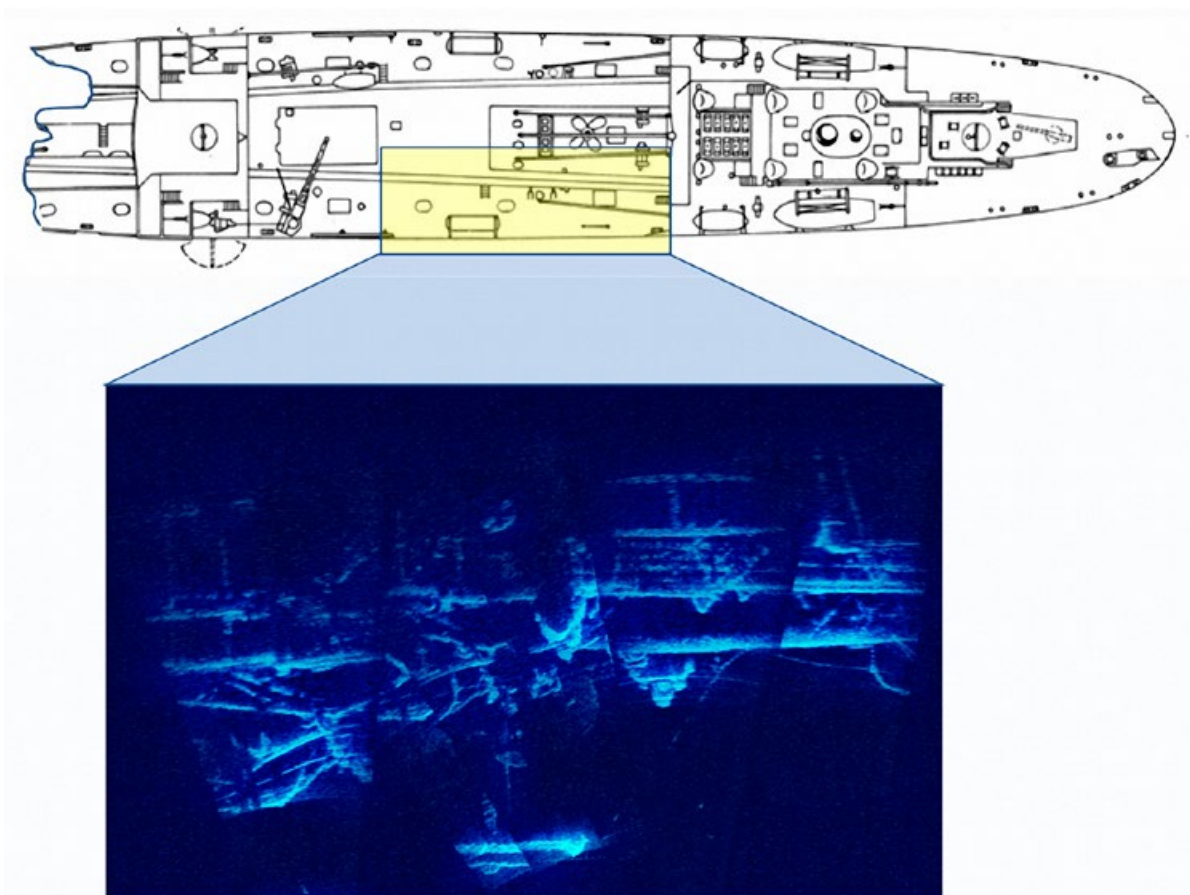
Figure 26. A mosaic of images from an acoustic camera ARIS, showing the main deck and the larboard section of approx. 30 m, from the sterncastle towards the forecastle (source: 2018 expedition)

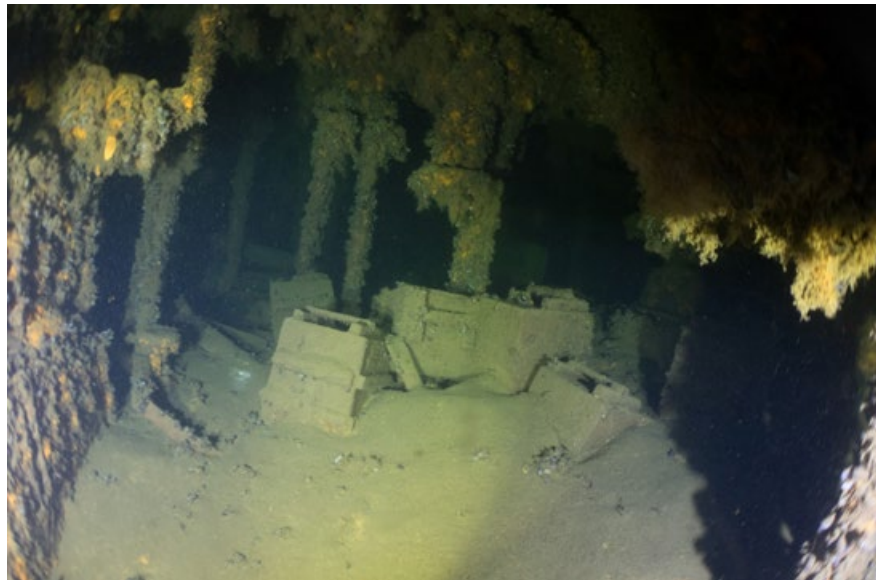
Photo 29. Boxes with unknown content (possibly with parts, although they look like a boxes with small calibre ammunition) on the main deck, under the fore-castle (source: 2018 expedition, © M. Czermiński)

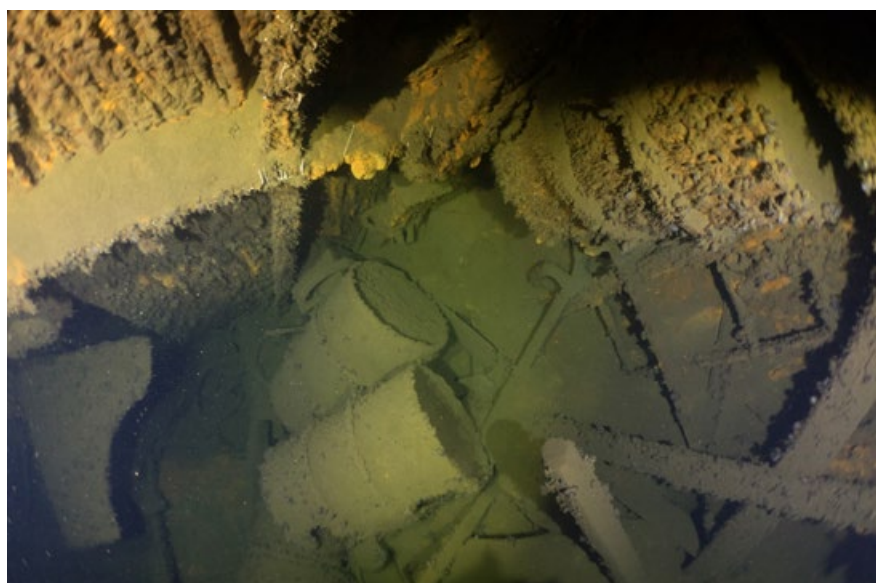
Photo 30. Barrels with unknown substance in the well of the control unit of oil valves (source: 2018 expedition, © M. Czermiński)
