Evaluating the Wreck of the WWII Tanker RFA War Mehtar

Matt Skelhorn
Salvage and Marine Operations (SALMO)
and
Stuart Leather (Waves Group)

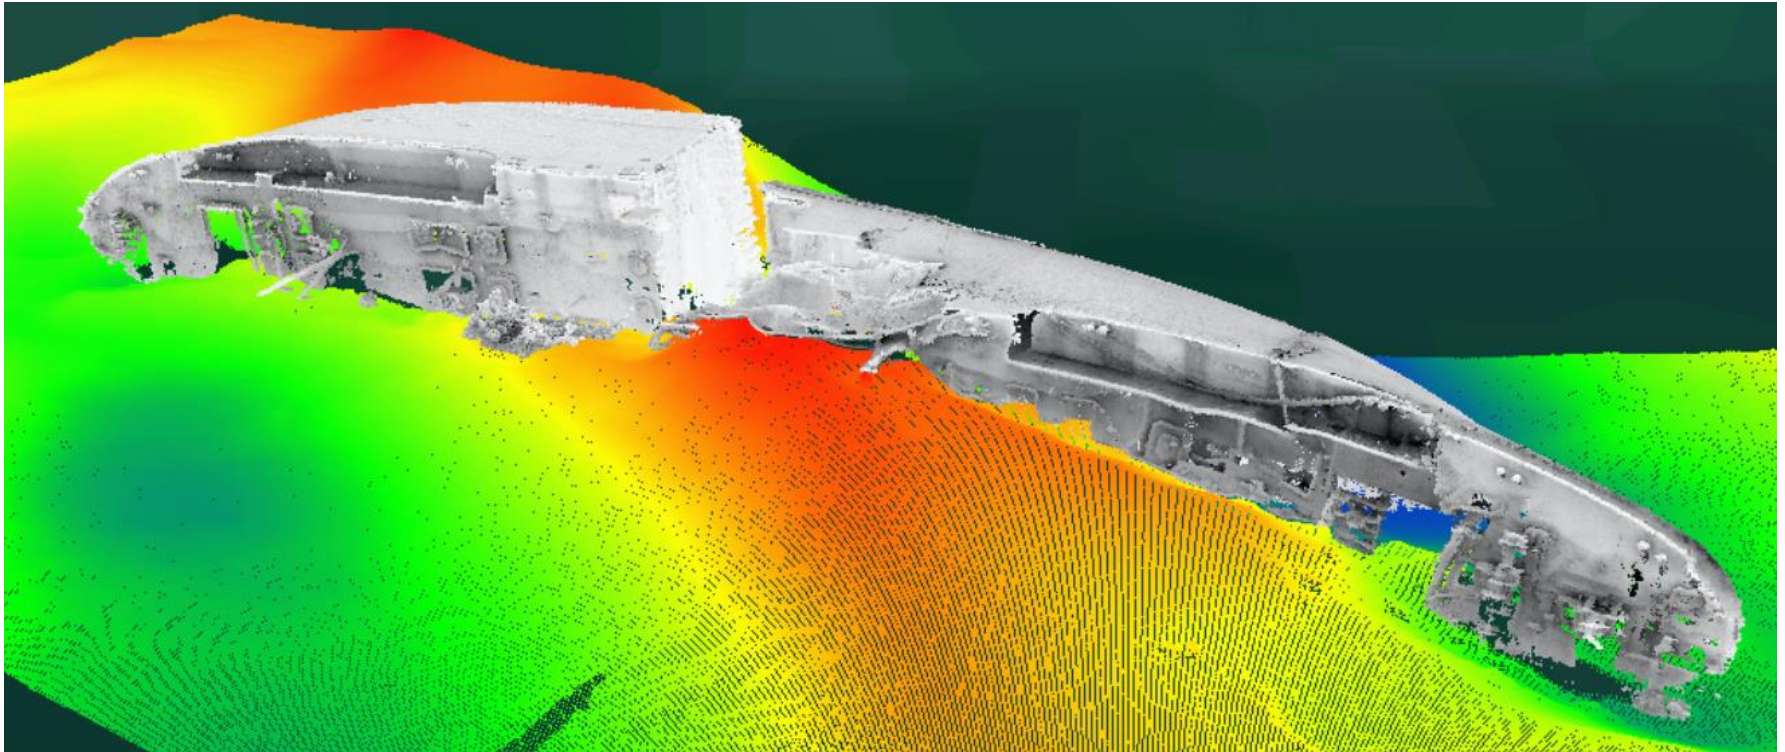
2019 multibeam data

- **Multibeam showed breaches in all tanks except tank 3**
- **NBS measurements didn't record any oil**
- **Some structural collapse specifically in the midships section since 2014 survey**
- **Plate beginning to collapse from frames**
