The UK MOD Wreck Management Programme

Matt Skelhorn
Salvage and Marine Operations (SALMO)

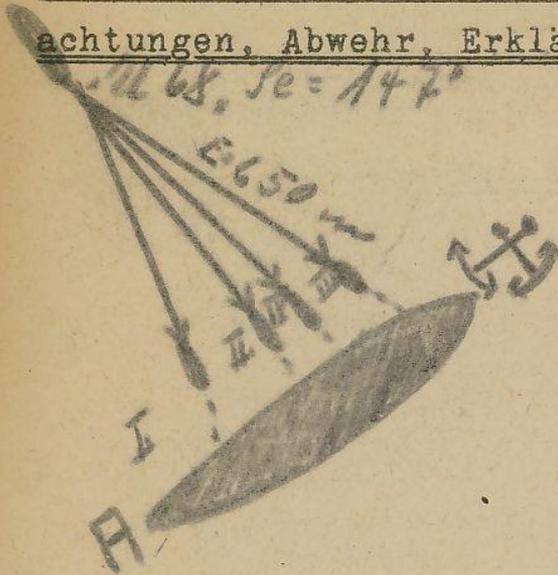
Anlaufskizze mit Schußbild. Wie sind Schußunterlagen erworben? Besondere Beobachtungen, Abwehr, Erklärung für Fehlschuß:

Ziel war vor Anker liegender Tanker von 8100 t. Tanker mußte unter allen Umständen sofort und restlos vernichtet werden. Dahernach den vorherigen ungeklärten Schüssen 4 Torpedos mit Schußwinkel 0.
