PRELIMINARY ACTION PLAN FOR THE RETRIEVAL ACTIVITIES ON THE FRANKEN SHIPWRECK

Report from the research expedition carried out on the Franken shipwreck on 23rd-28th April 2018 in the framework of the project
“Reduction of the negative impact of oil spills from the Franken shipwreck”

JUNE 2018

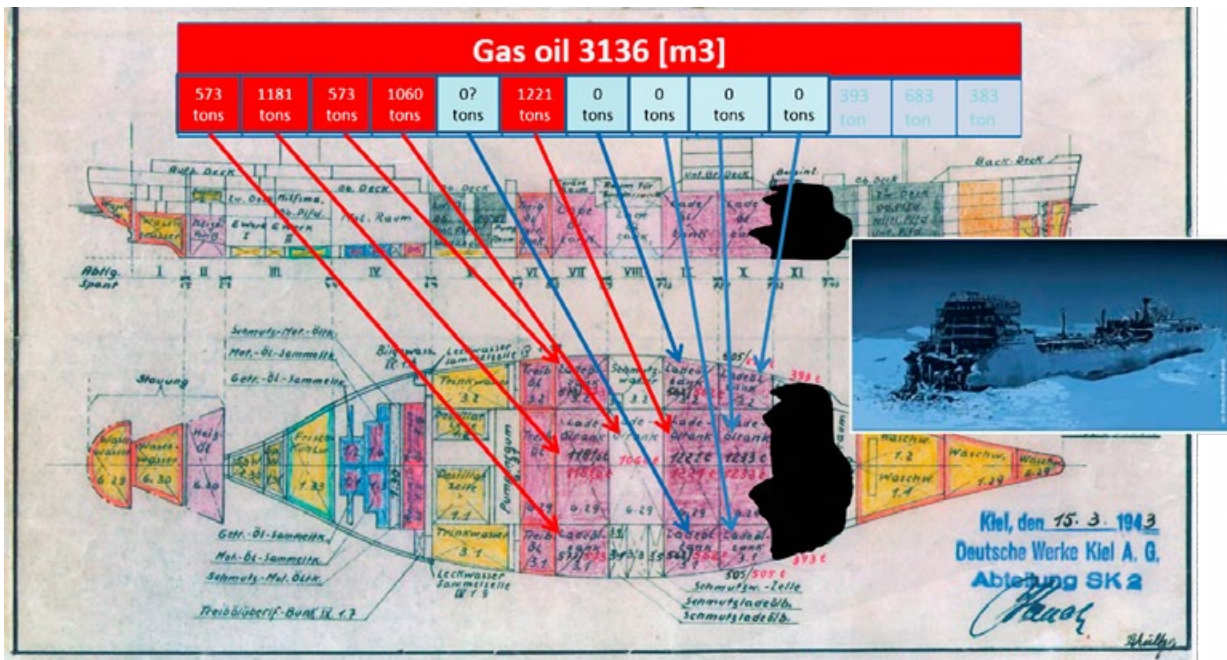
Figure 9. T/S FRANKEN – the undamaged tanks can accommodate approx. 4 thousand tonnes of oil. On the basis of the data from the reports, the amount of oil was estimated at maximum 3 thousand tonnes, and most probably much less, that is 2 thousand tonnes (source: historical plans, own description)

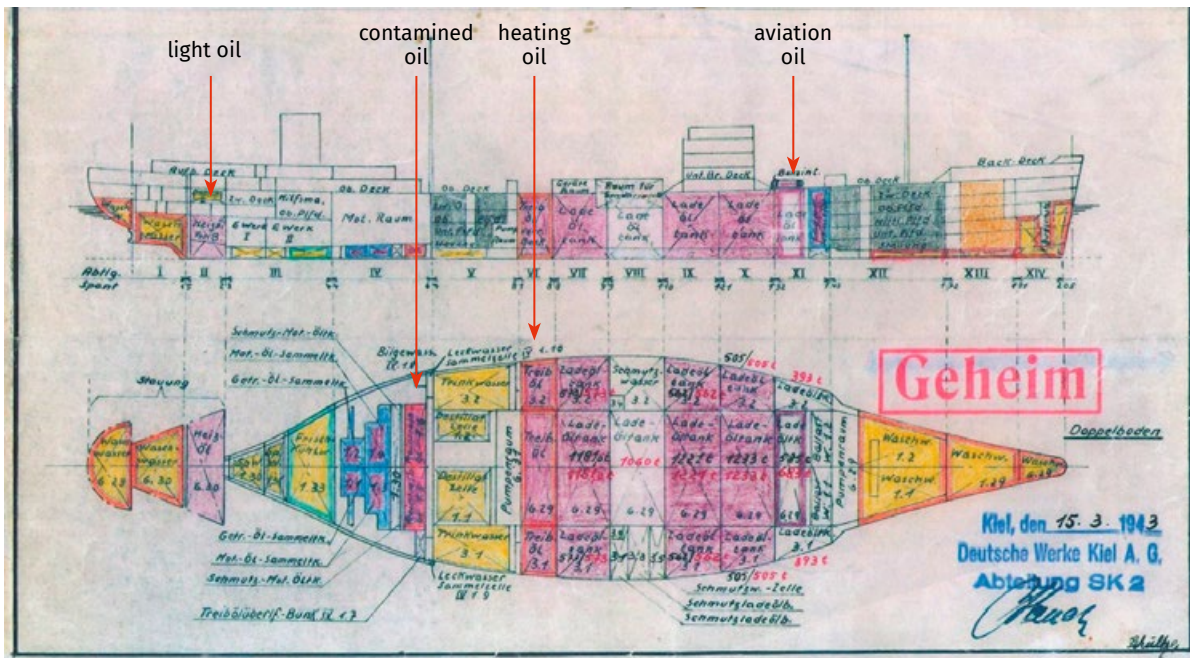
Figure 10. T/S FRANKEN – could have about one thousand tonnes of other petroleum products in its tanks (source: historical plans, own description)

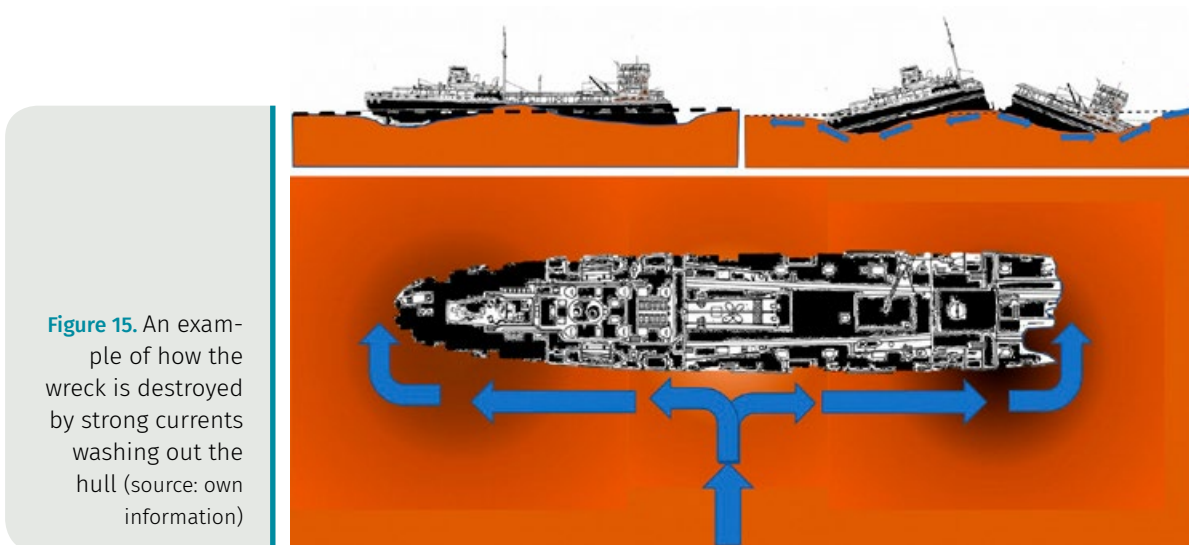
All wrecks are subject to decomposition. Usually, wrecks are decomposed according to a well-known scenario, due to the processes that occur on the sea bottom around a particular wreck. The usual scenario of the wreck decomposition does not apply in the case of this particular wreck (it usually refers to wrecks which are not broken), because the Franken was broken in two parts (the bow and the stern) after the bomb and oil explosions at the moment of sinking. The two sections of the wreck drifted away from each other by approx. 420 meters. However, the stern (the main section of the wreck), lying in an area of very strong bottom currents, which carry a lot of sediments, is subject to decomposition according to the scenario illustrated below (Figure 15). This means that in the near future this section of the wreck will completely decompose. Taking into account the progressive decomposition of the hull due to corrosion of the steel elements exposed to salt water, the hull will probably disintegrate in its central part and the forecastle, 10-12 meters high, will collapse (Figure 15).

Figure 15. An example of how the wreck is destroyed by strong currents washing out the hull (source: own information)

Breaking of the hull in the place where the two main oil tanks are located will cause an uncontrolled leakage of their content. A similar effect will occur if the bow superstructure, weighing over one thousand tonnes collapses on the oil deck. If the bow superstructure falls to the opposite side, the hull will break and the tanks will leak. Even such scenario is dangerous for the Gdańsk Bay.

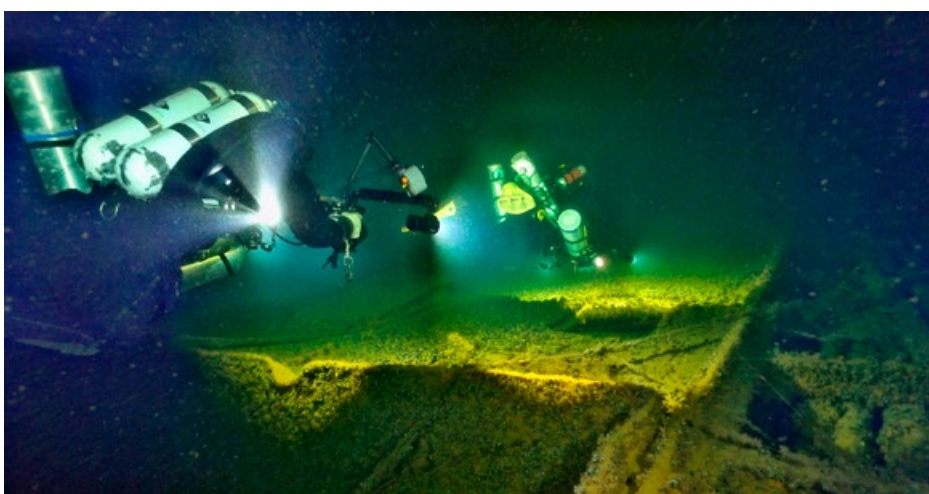
Photo 4. The deck in the area of the sterncastle, on starboard (source: 2018 expedition, © M. Pocaĵo)

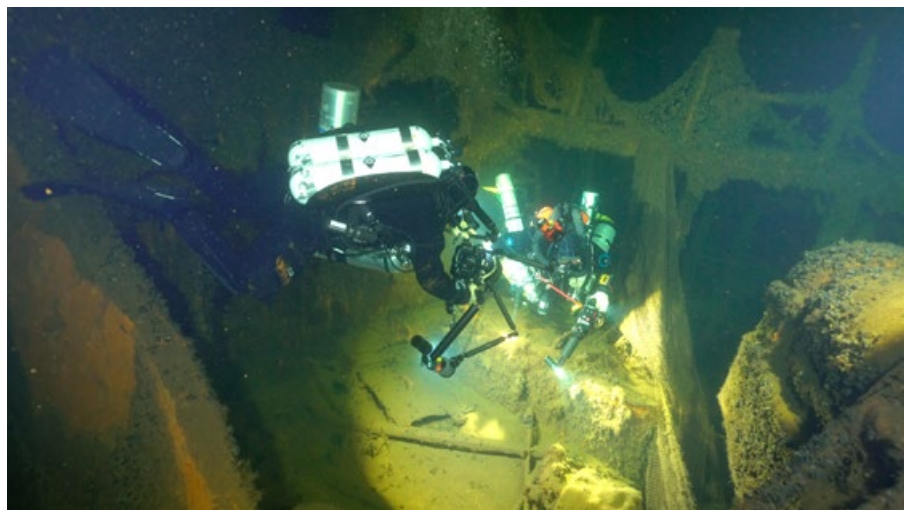
Photo 15. A hatch to an oil tank (source: 2018 expedition, © M. Czermiński)

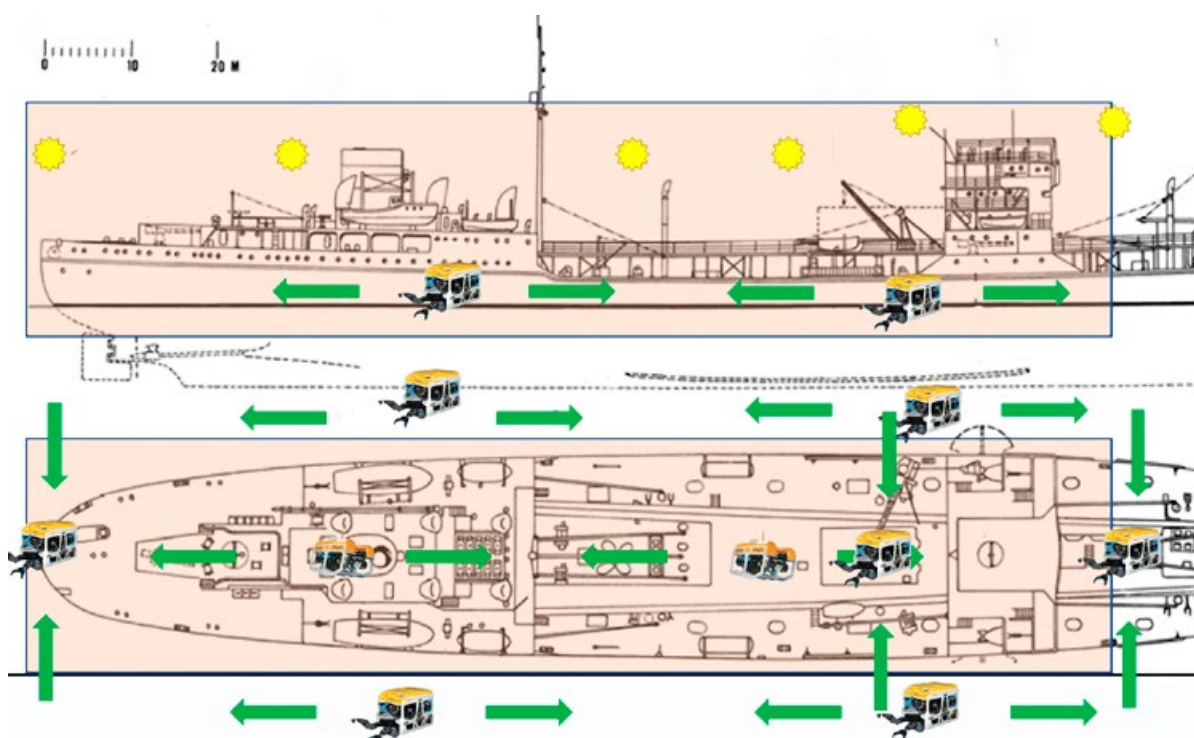
Figure 23. Documentation scheme of the Franken using an acoustic camera (own source)

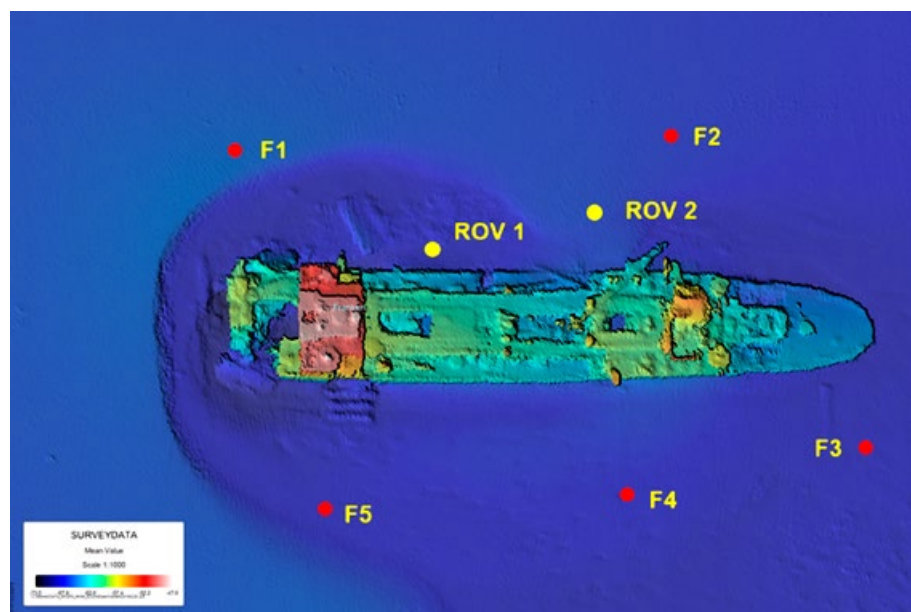
Photo 26. Sampling the sea bottom with a ROV next to the wreck (source: 2018 expedition)

The level of mineral oils in each kilogram of dry matter exceeds the limit value by 500-1000 times. A large quantity of phenols, ether extracts and very large quantity of organic carbon were found in the composition of detected substances. The presence of such a large amount of organic carbon indicates that a quick sedimentation of organic substances (apart from contamination) takes place around the wreck. This is not surprising, because the wreck lies within the range of water flowing from the Vistula river (it is located just in front of the Vistula river mouth) and the verge of the Gdańsk Deep, where the conditions for biological life are extremely unfavourable due to shallow layers of hydrogen sulphide.

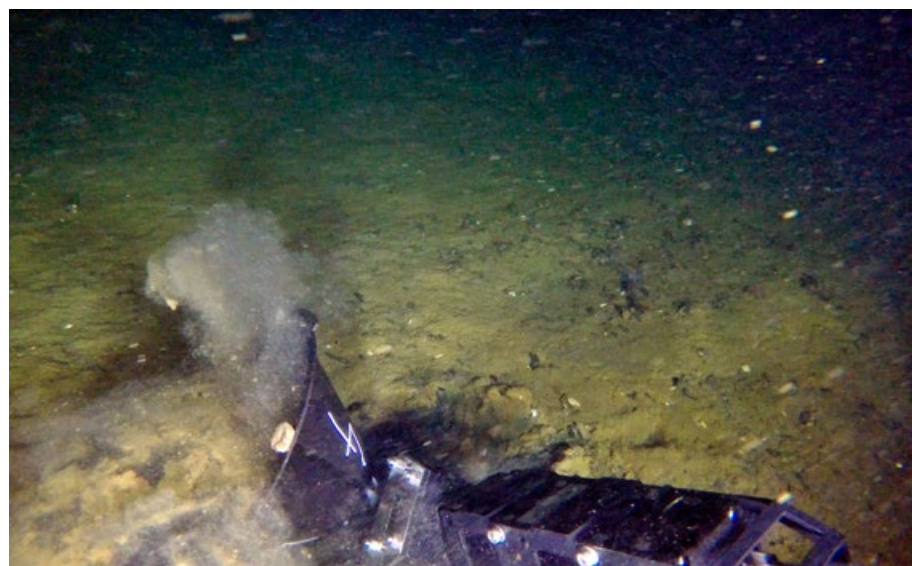
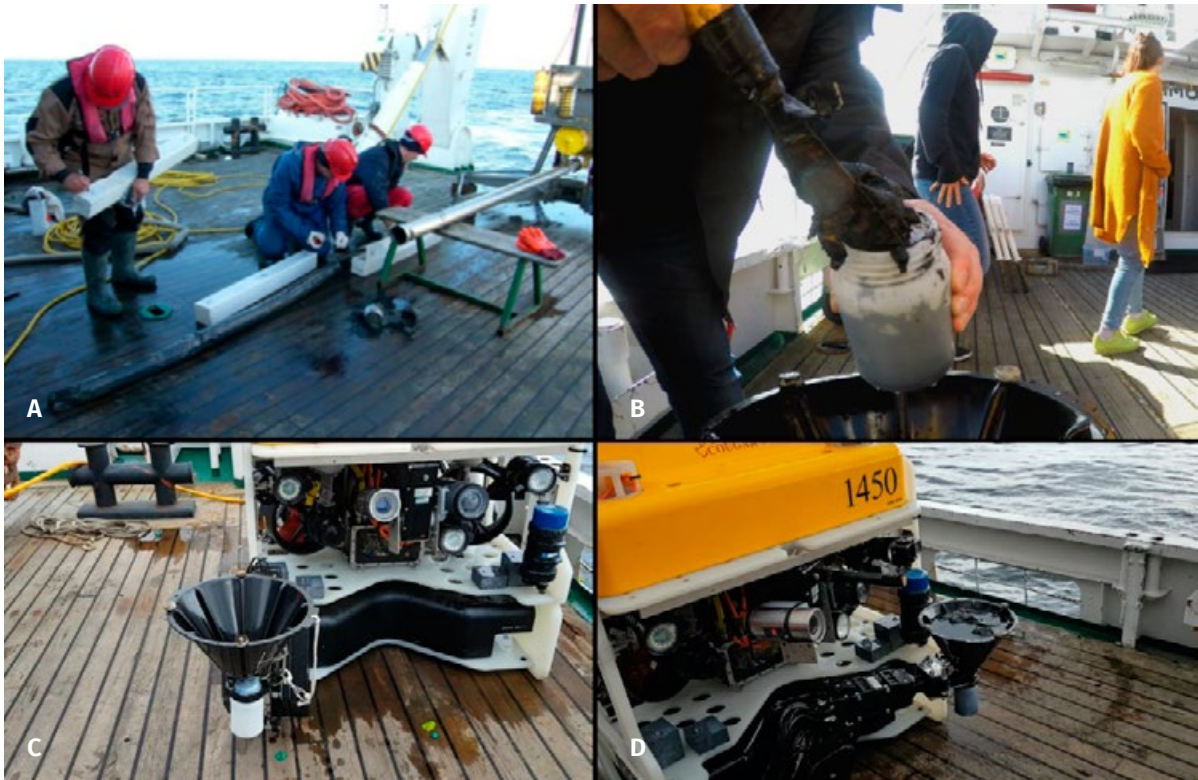
Photo 27. Methods used for sampling the sea bottom around the Franken (LT – vibroprobe VKG 3, RT – collecting the sample into a container send to the laboratory, LB – ROV vehicle with a probe before descending to the bottom, RB – ROV with a collected sample) (source: 2018 expedition)

Sampling in the zone situated closer to the wreck was done using a remote control vehicle, because the use of a vibroprobe without strict supervision of the place, where sampling is carried out could result in a detonation of an unexploded bomb. There are many unexploded ordnance around the wreck.
