Evaluating the Wreck of the WWII Tanker RFA War Mehtar

Matt Skelhorn
Salvage and Marine Operations (SALMO)
and
Stuart Leather (Waves Group)

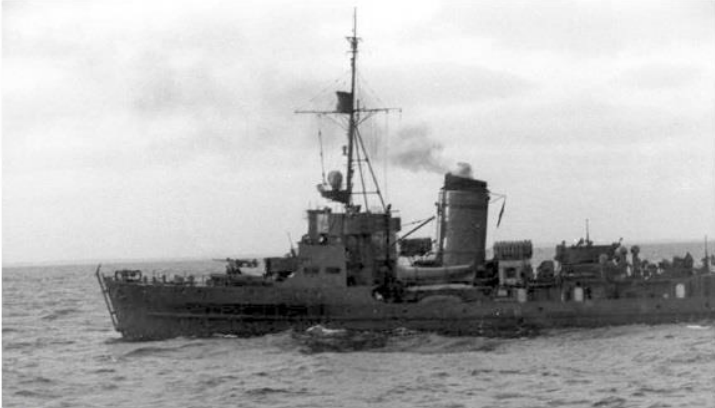
An M-class minesweeper.

Scuba divers in Jersey have reported seeing mercury leaking out of the World War Two shipwreck of the German minesweeper M-343. 20 November 2019

They recently observed large pools of the liquid metal collecting on the deck of the vessel – it had previously been seen only inside the wreck, according to a report in the Jersey Evening Post.

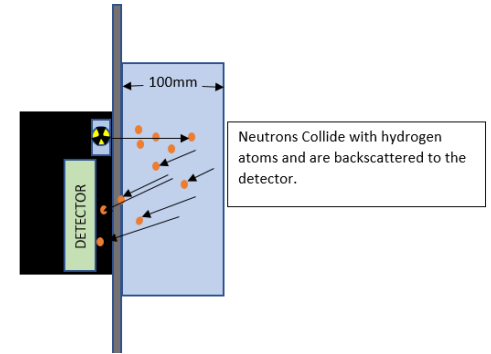
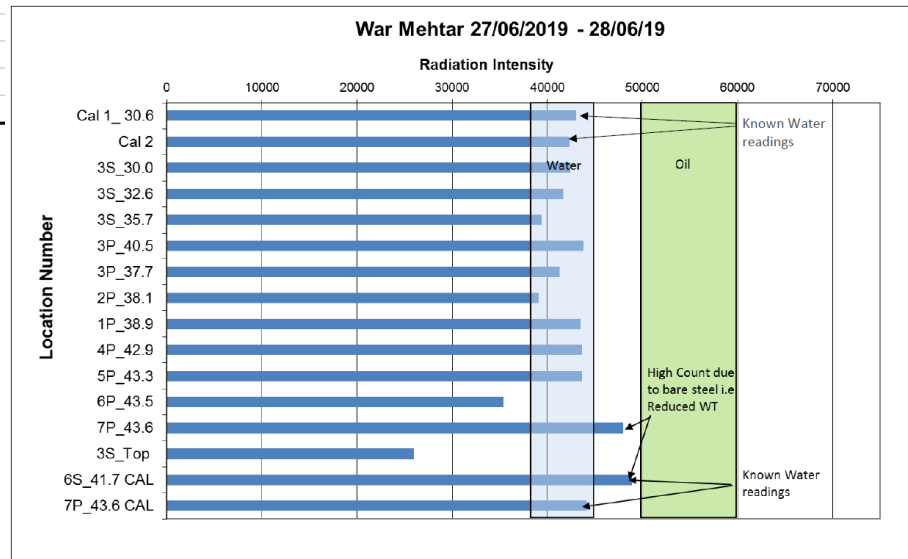
- **Multibeam showed breaches in all tanks except tank 3**
- **NBS measurements didn't record any oil**
- **Some structural collapse specifically in the midships section since 2014 survey**
- **Plate beginning to collapse from frames**
